GOPHER CONSTRUCTION COMPANY

Subject: Evaluation and Certification of an Existing Onsite Wastewater Treatment System per Health Dept. requirements at:
18777 Little Tujunga Canyon Road, Santa Clarita, CA 91387

EVALUATION FORM FOR EXISTING OWTS PROJECT REVIEWS

Septic System Drawing

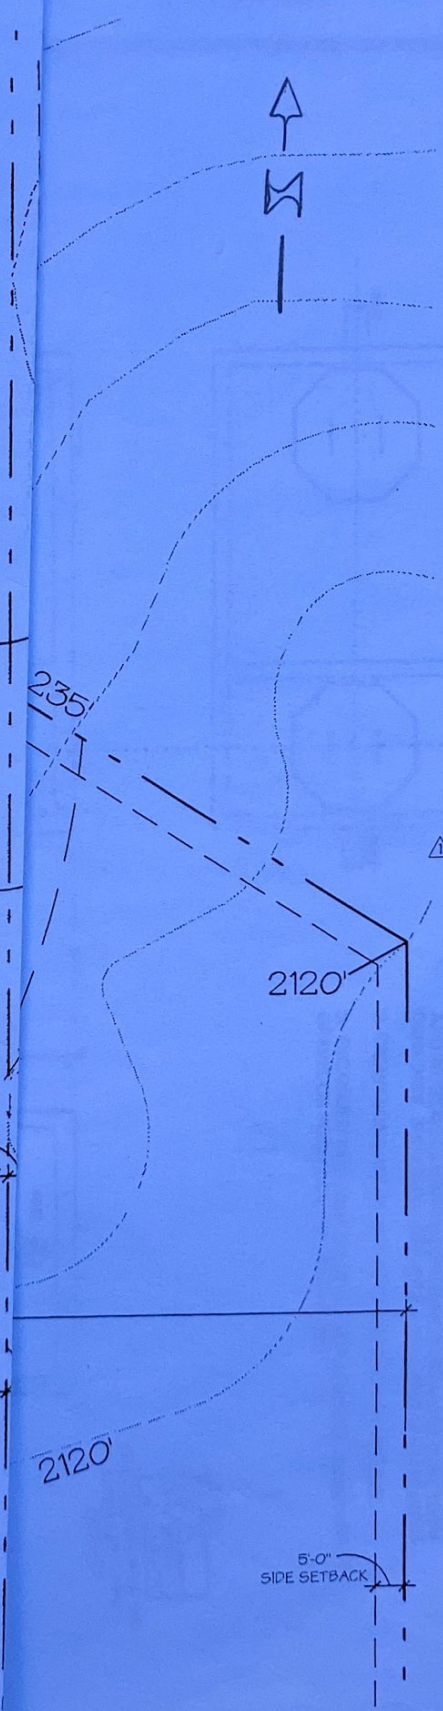
Unit 1: A 1200-gallon septic tank. (#1 on As Built Drawing)

Unit 2: A distribution box. (#2 on As Built Drawing)

Unit 3: A 50-ft long 20-ft wide leach field. (#3 on As Built Drawing)

Unit 1: The septic tank is located on the northwest side of the house and partially under the pathway to the front entry. The location of this septic tank is in a code compliant location without any set-back issues. There are no openings up to the surface on this septic tank. The inlet end of the septic tank was uncovered and opened by others. We excavated, uncovered, and opened the outlet end of the tank. We inspected the septic tank through these two openings. The top of the tank is 1-ft 9-in deep below the surface. The T-fittings on the inlet and outlet ends of the tank were missing. We repaired both T-fittings. The septic tank appears to be a "Pyramid" precast septic tank. (A spec sheet of the tank is attached). There was a heavy buildup of solid waste in the septic tank and it was pumped on February 27, 2020. We used our Video Camera and Electronic Locator to check the pipe from the house and it was melted from the fire. We replaced the pipe when we repaired the inlet T-fitting and installed a cap on the end of the pipe for future connection to the new house. The septic tank is the correct size for a 4-bedroom house. We inspected the tank and it appears to be structurally sound. The tank appears to have been installed correctly. After our pumping, inspection, and repairs, we closed and sealed the openings, backfilled both excavations, and cleaned up the area affected by our work.

Unit 2: The distribution box is located to the northwest of the septic tank and in the dirt area. It has no opening up to the surface. We used our Video Camera and Electronic Locator through the outlet pipe of the septic tank to check the condition of the pipe and to locate the distribution box. The outlet pipe was free of damage, but had some grease build-up, so we Hydro-Jetted the pipe and it is now free and clear of any obstructions. We then excavated, uncovered, and opened the distribution box for inspection. The top of the distribution box is 4-ft deep below the surface. The distribution box was in good condition with one pipe entering from the septic tank and two pipes exiting to T-fittings and then to the 4 perforated pipes in the leach field. The distribution box was free and clear of any obstructions and was structurally sound. After inspection, we resealed the distribution box, backfilled the excavation, and cleaned up the area affected by our work.

Unit 3: The leach field is located to the north of the distribution box, (**Unit 2**) and in the dirt area. The location of this leach field is in a code compliant location without any set-back issues. There were no openings up to the surface of this leach field. We located the perforated pipes of this leach field by using our Pipe Video Camera and Electronic Locator through the distribution box. We were only able to get our camera to the beginning of the perforated pipes because of the sharp 90 degree bends in the pipe. We located, excavated, and uncovered all four pipes at the beginning of the leach field. We used our Pipe Video Camera through each perforated pipe and we observed that the pipes were free of damage, but had a build-up of sludge inside the pipes. We installed a clean-out up to the surface at the beginning of each perforated pipe for access for our Hydro-Jetter and for maintenance cleaning in the future. The four perforated pipes are 4-ft deep below the surface and are spaced 5-ft apart from each other. We excavated and uncovered a small portion of the perforated pipe and inspected the condition of the gravel under the pipe. The gravel was clean and shows no signs of any full or overfull conditions in the past. The gravel under the pipe is 3-ft deep below the pipe. After our inspection and repairs, we backfilled our excavations and cleaned up the areas affected by our work. We used our Hydro-Jetter through the new clean-outs to clear the sludge from the pipes. The leach field took all the water from our Jetter without any water backing up.

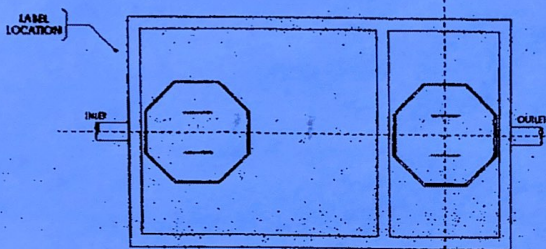
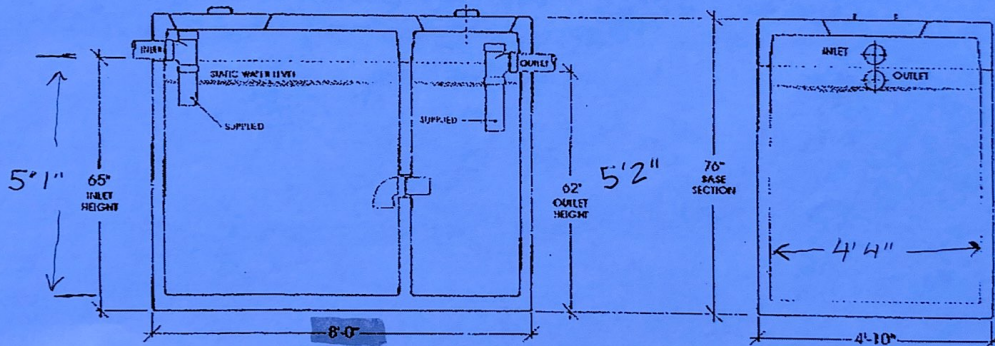
1200 GALLON Residential Septic Tank

Unit 1: The septic tank is the correct size for a four-bedroom home, is intact, was installed/constructed in an acceptable manner, is in good repair, is structurally sound, and has no apparent functional deficiencies. The pipes throughout the system are now clear, flowing freely and functioning properly.

1. Optional: If desired, manholes could be installed up to the surface on the septic tank for easier maintenance pumping in the future. Range of Cost: \$1,200.00 to \$1,800.00 or more depending on site conditions.
2. Please note the Maintenance recommendations listed below. There are no other recommendations at this time.
